Subject: Joyner Slope Consultation
2603 Carpenter Rd SE, Lacey, WA
QG Project No.: QG21-007

At your request, Quality Geo NW, PLLC (QG) has completed a limited evaluation of the existing developed slope face on your property. We understand the general quality of the slope, surface, and waterside improvements is in question. Further information has been requested by the permitting authority to inform if it is acceptable for the site to remain in its current condition, and if there may be any additional improvements.

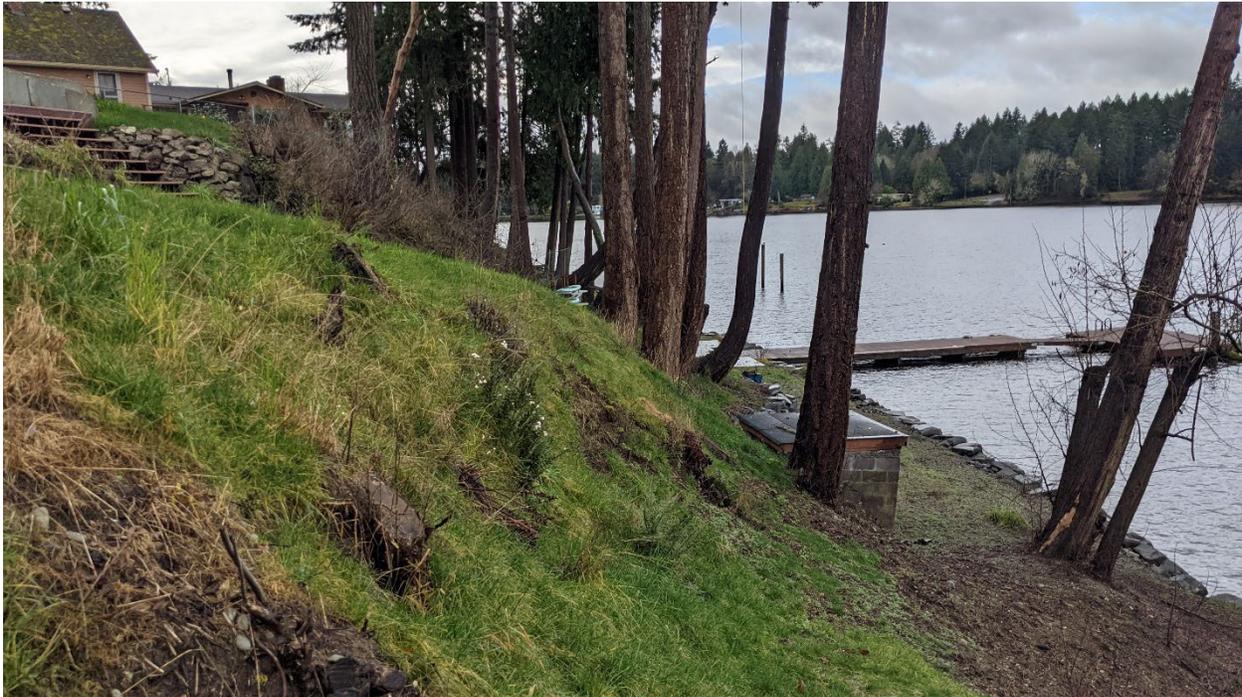
Photo 1. Typical slope profile conditions.

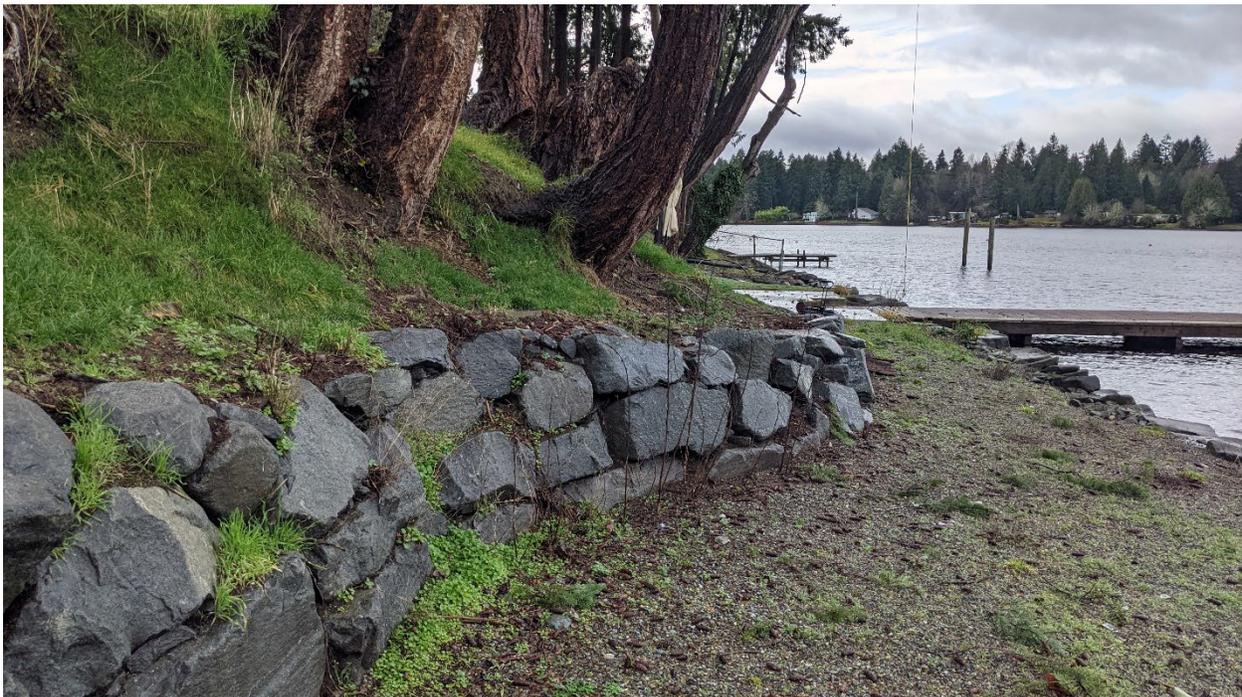
Photo 2. Slope toe conditions.
