- Preliminary Tree Protection Plan -

**BRITTON NORTH**

2365 Shady Lane Ct. NE  
Lacey, WA 98516

Prepared for: Lacey Community Development  
Prepared by: Washington Forestry Consultants, Inc.  
Date: December 7, 2021

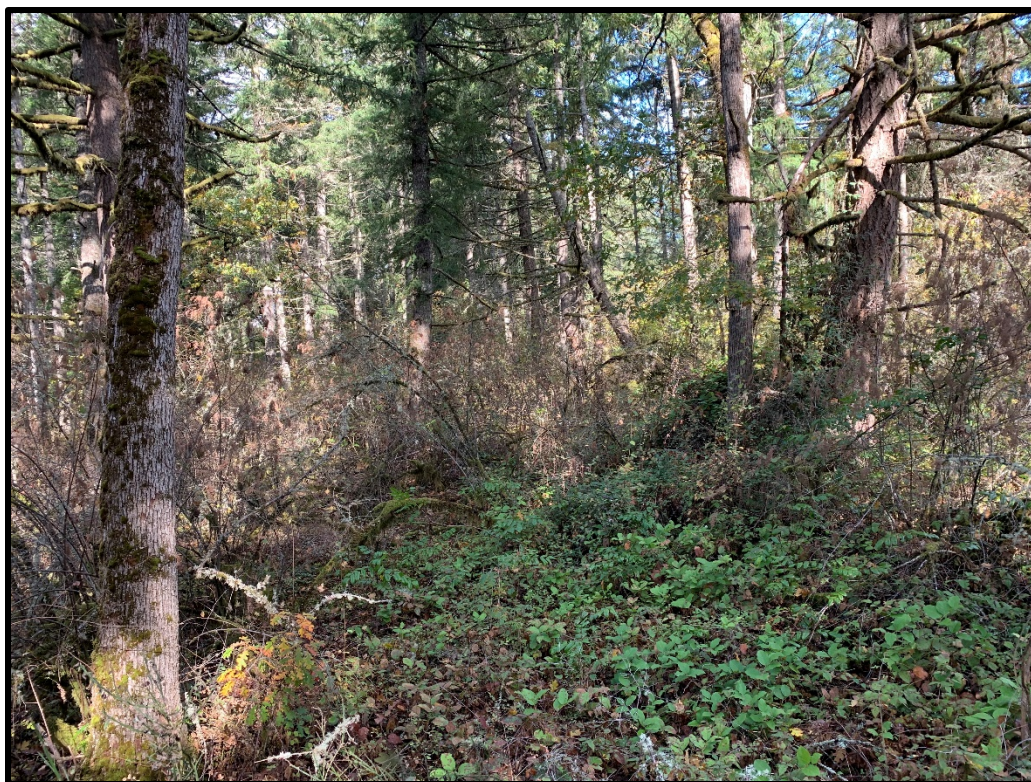
We project that 2,465 trees are growing in this type. The condition of living trees ranges from ‘Dead’ to ‘Good’ condition, with about 80% of trees described as being in ‘Fair’ or better condition. This leaves about 1,963 healthy, long-term trees in this cover type. Mortality in this stand is due primarily to drought stress.

**Photo 1.** View of trees in Type I on Britton North site.

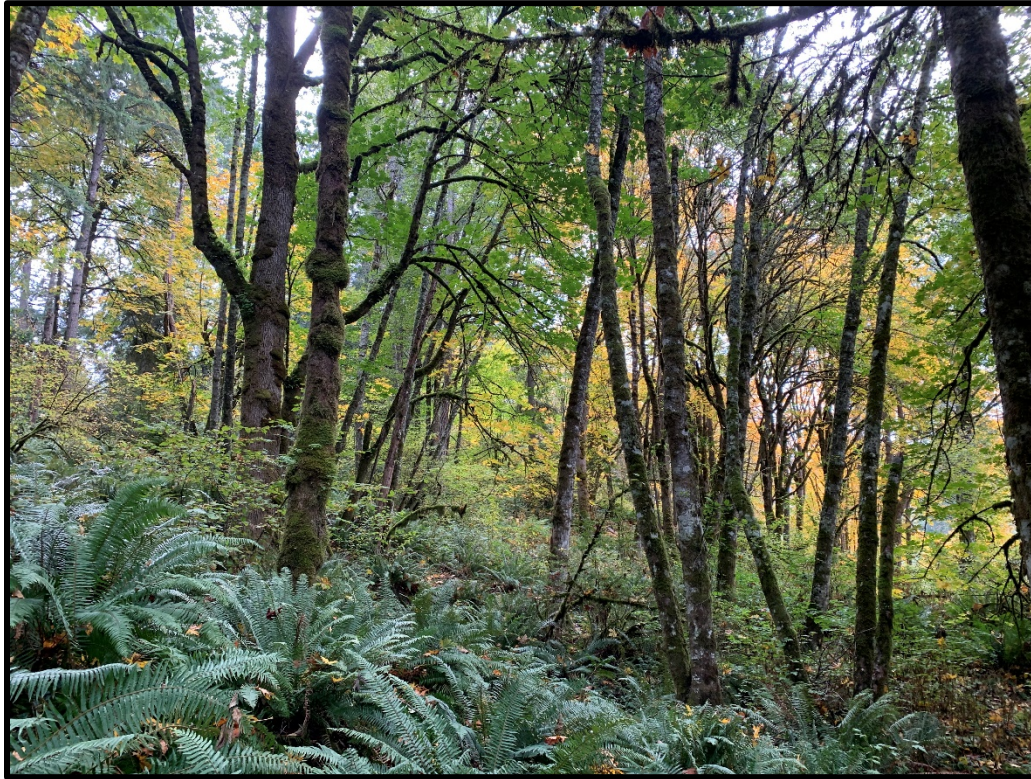
We project that 425 trees are growing in this type. Tree conditions range from ‘Very Poor’ to ‘Good’, with about 84% of trees described as being in ‘Fair’ or better condition. This leaves about 358 healthy, long-term trees in this cover type.

**Photo 2.** View of trees in Type II on Britton North site.

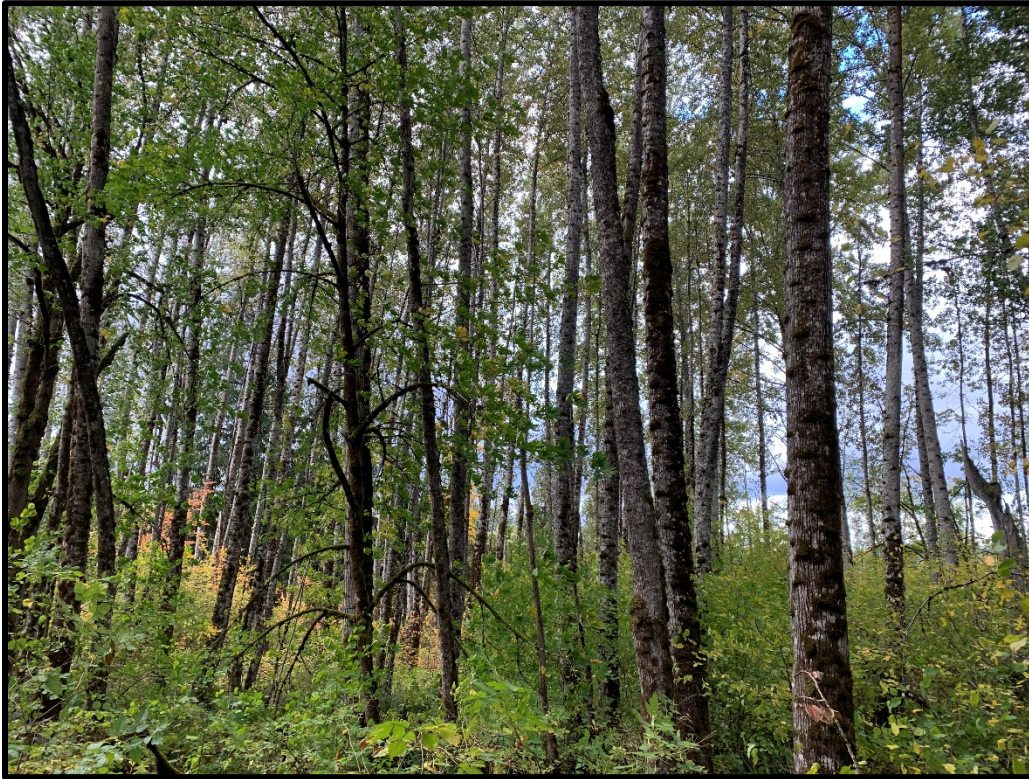
We project that 369 trees are growing in this type. Tree conditions range from ‘Poor’ to ‘Fair’, with about 76% of trees described as being in ‘Fair’ or better condition. This leaves about 299 healthy, long-term trees in this cover type.

**Photo 3.** View of trees in Type III on Britton North site.

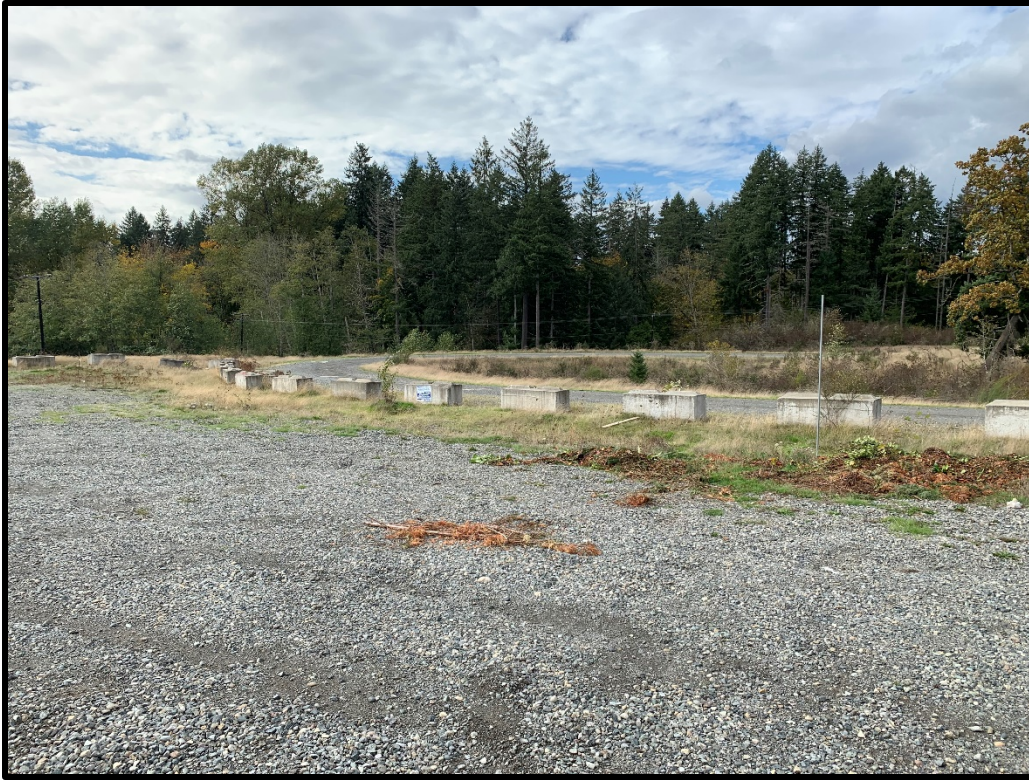
Type IV.- This cover type covers the cleared areas of the project area including the City of Lacey pump station and the connected roadway. The type occurs along the western side of the site. There are no trees in the type.

**Photo 4.** View of cover Type IV on Britton North site.

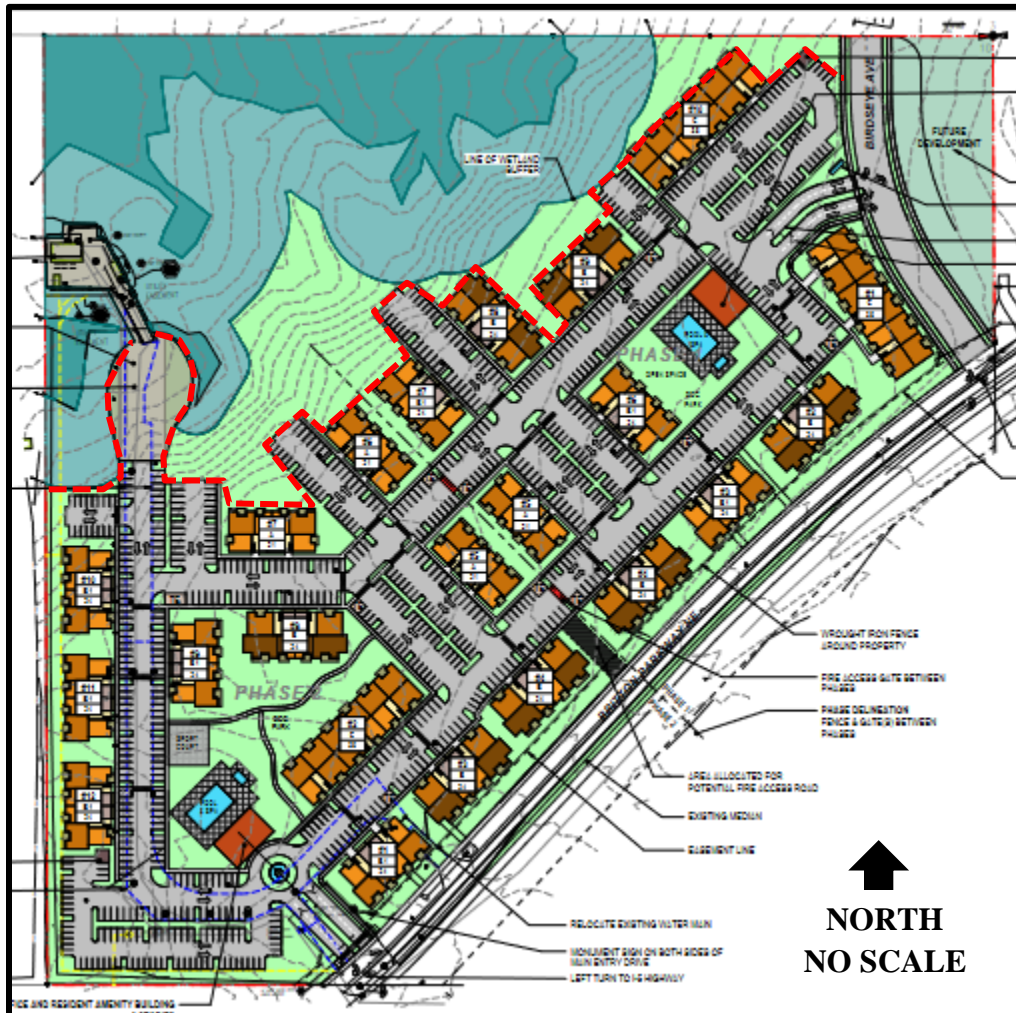
## Attachment 2. Britton North Site Plan

**The site plan does not show a dedicated tree tract area. It needs to be shown on the site plan and the area calculated.** It must be outside of the wetland and buffer on the site.

Update the site plan to show the required 5% tree tract. WFCI will then update the tree protection plan. Then submit ‘tree protection plan map’ on the face of the grading plan to the City of Lacey for approval. The tree plan map should include the tree tract boundaries, the locations of tree protection fencing, a tree protection fence schematic and this ‘Timeline for Tree Protection Activity.’ The tree protection plan map should be part of the construction drawings packet sent out to contractors for bid.
