SOUND URBAN FORESTRY, LLC

RE: City of Lacey Lift Station 6 Rehabilitation Project Tree Removal and Protection,

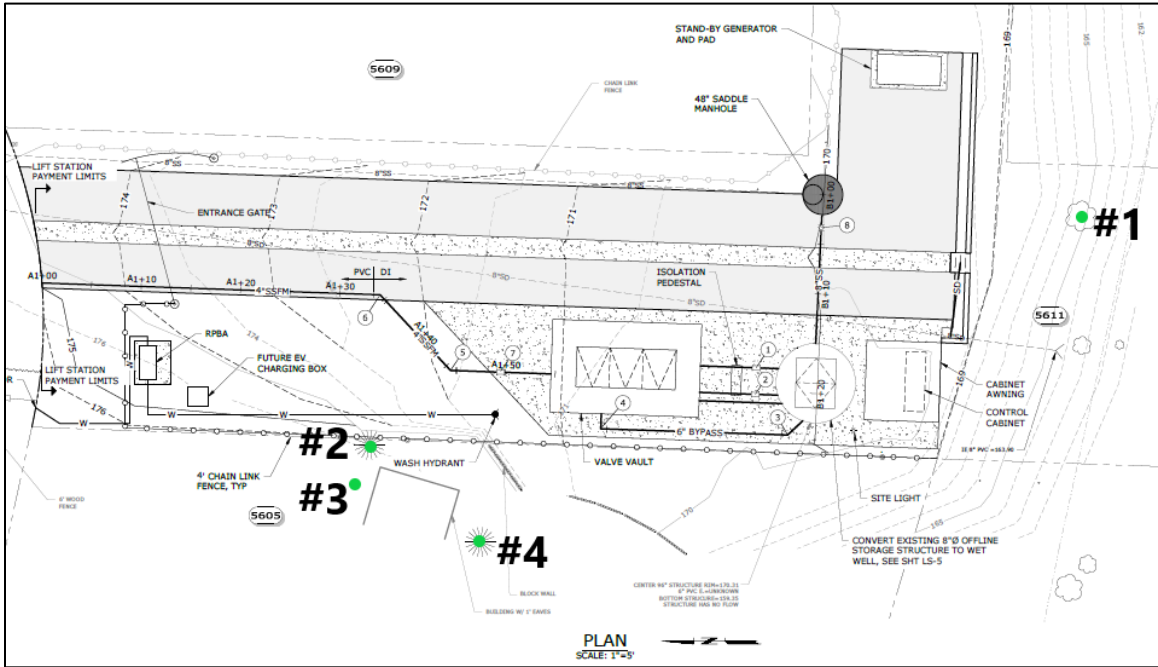
Locations of Assessed Trees

While at the site, the property owner at 5609 32nd Ct SE requested that a pine tree be removed because it had lost branches in the past and currently has a few dead branches hanging in the canopy. This tree is noted as #1 on the attached site plan.

Tree #2: 32” western red cedar. Approximate height of 80’ with 30% live canopy ratio (LCR). The overall structure of this tree is poor. Its main stem splits into co-dominant leaders at 50’ with 2’ of inclusion at the union. The tree leans toward the lift station drive and the adjacent property at 5609 32nd Ct SE. Potential targets include the drive at 12’ and house at 38’. It is considered a “high” risk.

I recommend that Tree #2 be removed due to its risk rating and the conflict with the proposed security fence location. The stump should be grinded to 16-18” below grade to provide clearance for the fence. I see no reason to remove the other three assessed trees.
