SOUND URBAN FORESTRY, LLC

2/6/2024

RE: Lakeview Meadows Utilities Project Tree Assessment, Case #24-0017

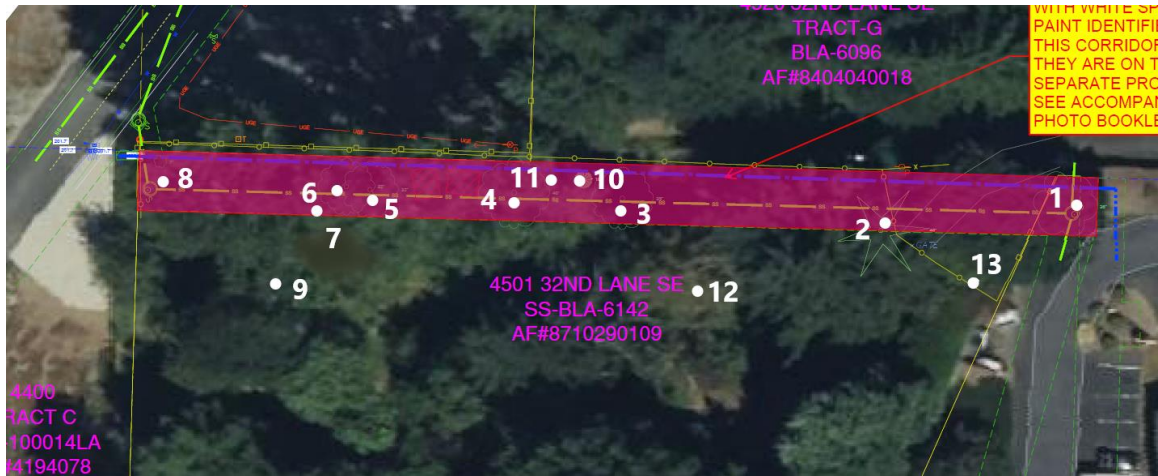
Locations of Assessed Trees

A total of thirteen trees were assessed within and along the easement, see the attached aerial of the site. The information gathered and my recommendations are presented in Table 1. The trees have been marked with an 'X' in white paint.
