CITY OF LACEY LIFT STATION 6 REHABILITATION

Critical Areas Report

Prepared for
Conсор and City of Lacey

June 2023

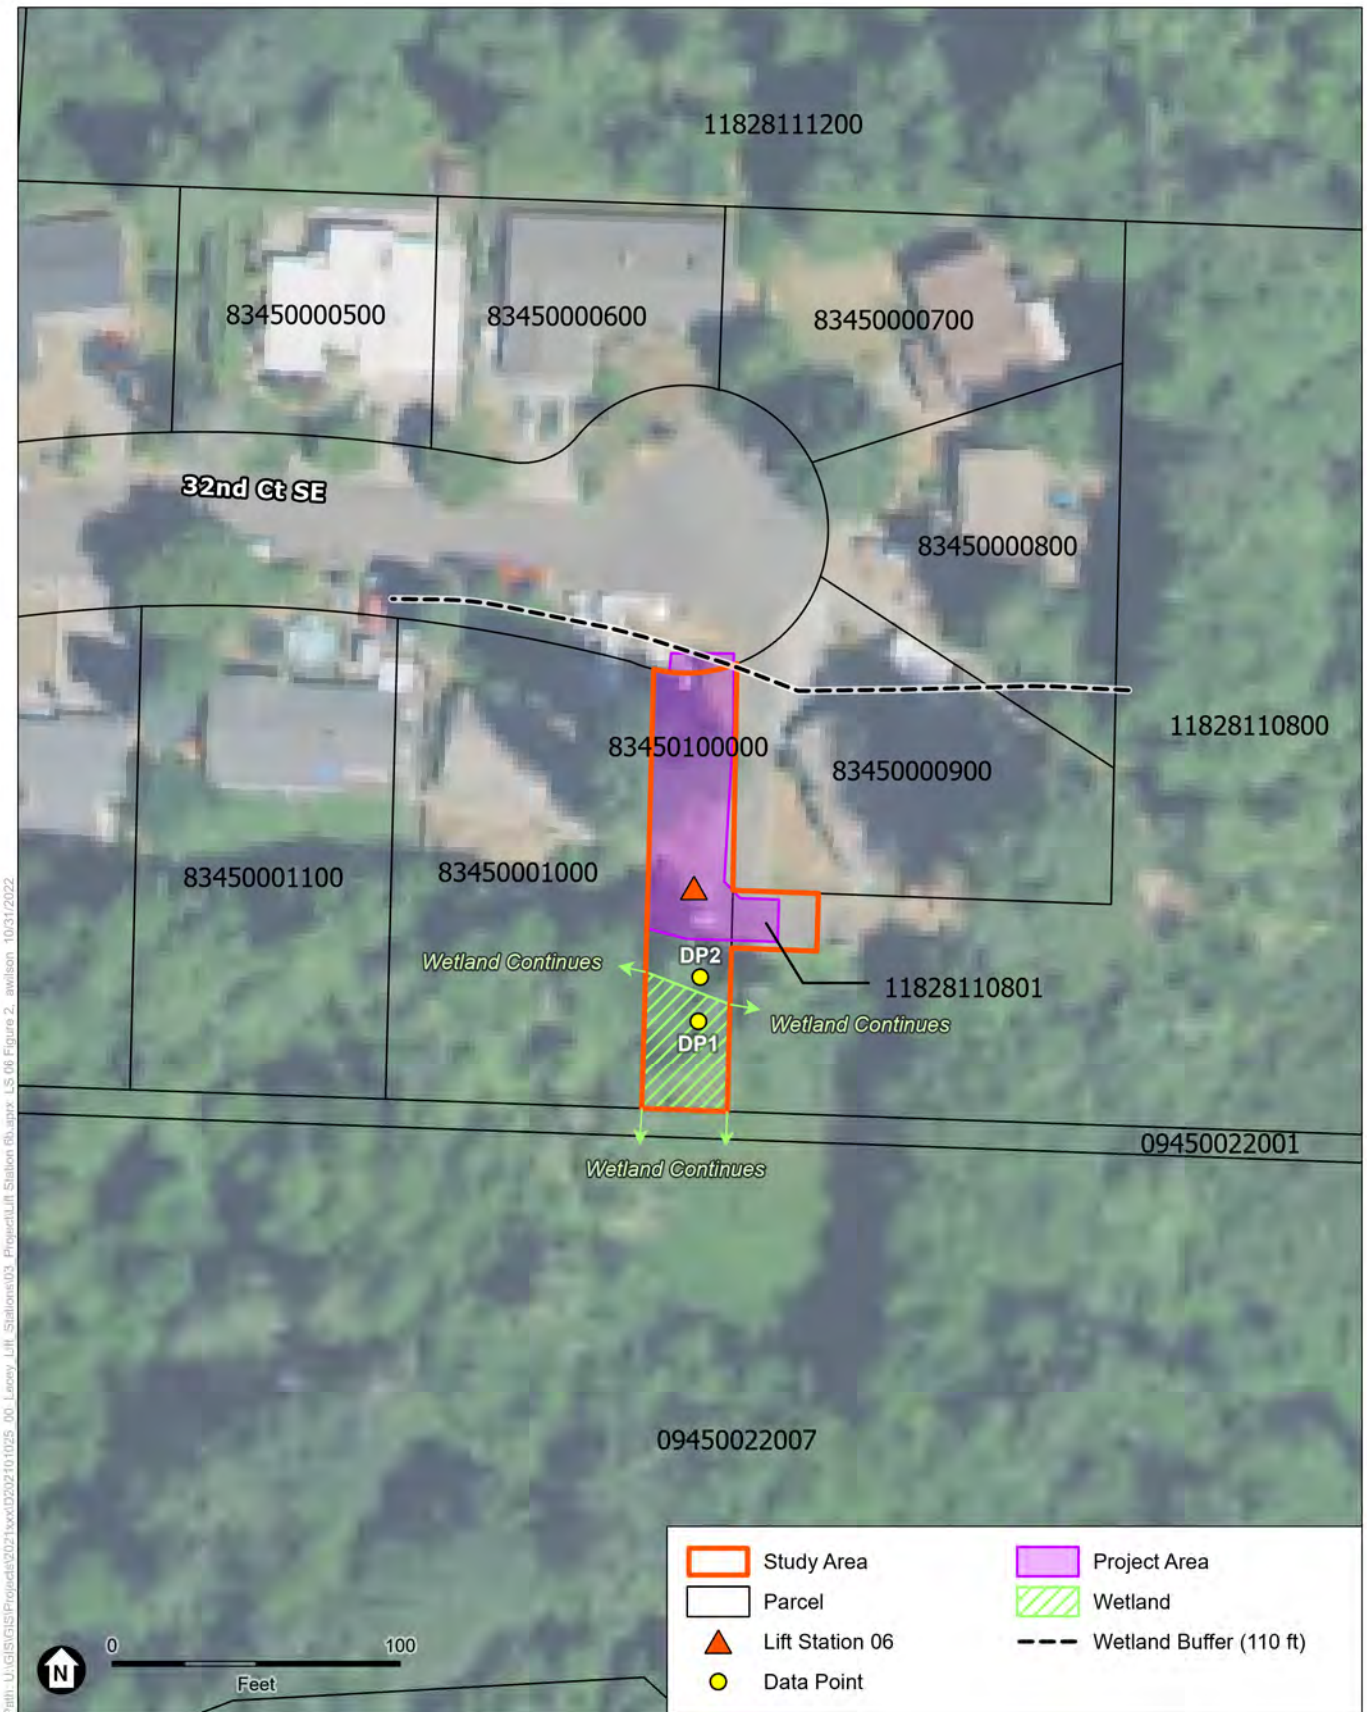
Figure 4
Critical Areas - Wetland Delineation Map
Lift Station 6

Wetland 1 is a category II depressional and flats, palustrine forested (PFO)/palustrine shrub scrub (PSS) wetland feature delineated along the southern slope of the study area. Wetland 1 extends off-site to the east, west, and south. During the time of field investigation, at least 2 inches of standing water (A1) was observed 2 feet away from DP1. At DP1, biologists observed a high water table (A2) and soil saturation (A3) measured to the surface of the soil plot.

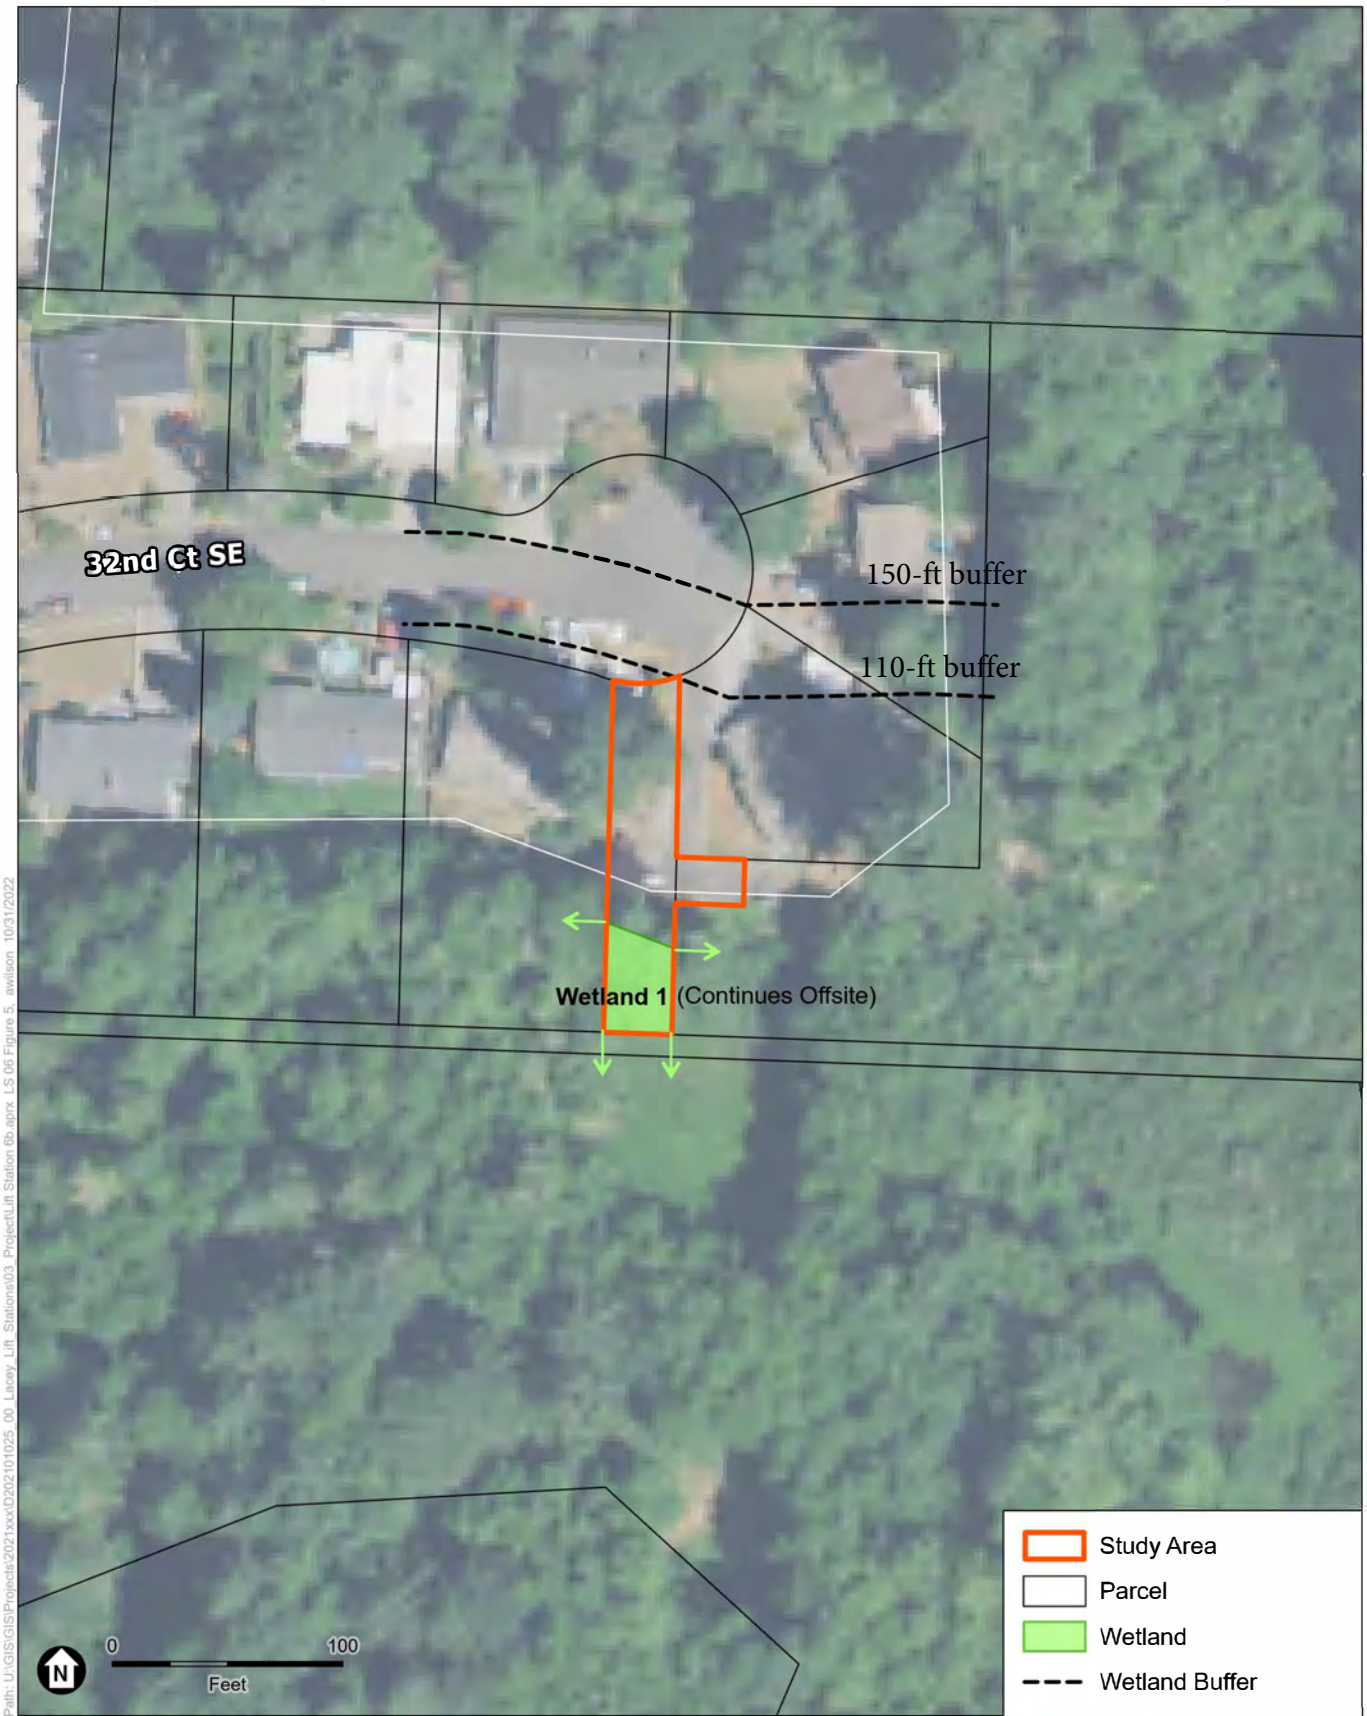
Figure 5
Wetland Rating Figure A
Lift Station 6

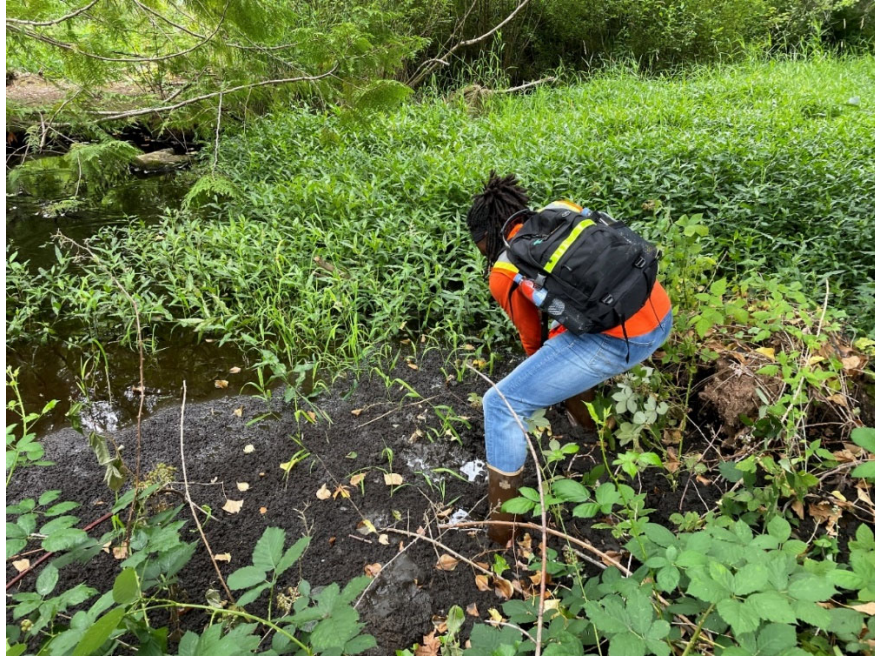
Photo 1

Wetland 1, DP1 facing southwest

The Web Soil Survey maps Indianola loamy sand as the single soil type within the study area. Indianola loamy sand is a somewhat excessively drained soil that is common on sandy glacial outwash and considered nonhydic by the Natural Resources Conservation Service (NRCS 2022a). However, 15 percent of the mapped soil can include hydric soils (**Figure 4**). ESA observed soil conditions at DP1 during delineation. The entire layer (0–16 inches) within the data plot consisted of black (7.5YR 2.5/1) silt loam. Redoximorphic features were too saturated to view but biologists assumed soils were hydric based on presence of surface water adjacent to DP1 (**Photo 1**).

Wetland vegetation within the study area is mostly wooded with a mixed coniferous-deciduous forest primarily dominated by western red cedar (*Thuja plicata*) and bigleaf maple (*Acer macrophyllum*) in the tree canopy. The emergent class was dominated by reed canary grass (*Phalaris arundinacea*) and fringed willowherb (*Epilobium ciliatum*). Non-native or invasive vegetation present includes Himalayan blackberry (*Rubus bifrons*) (Photo 1).

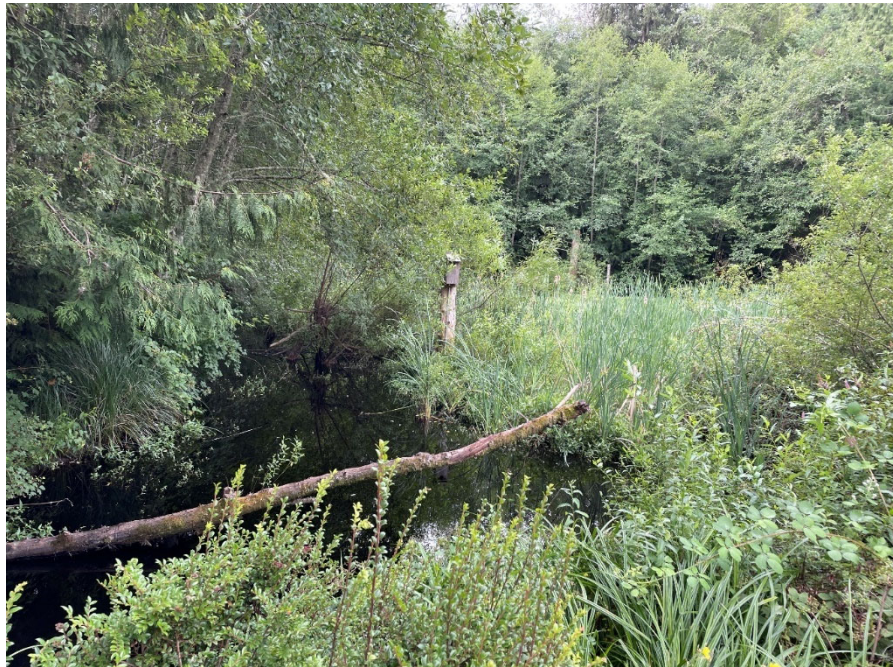
Photo 2

Wetland 1, facing south

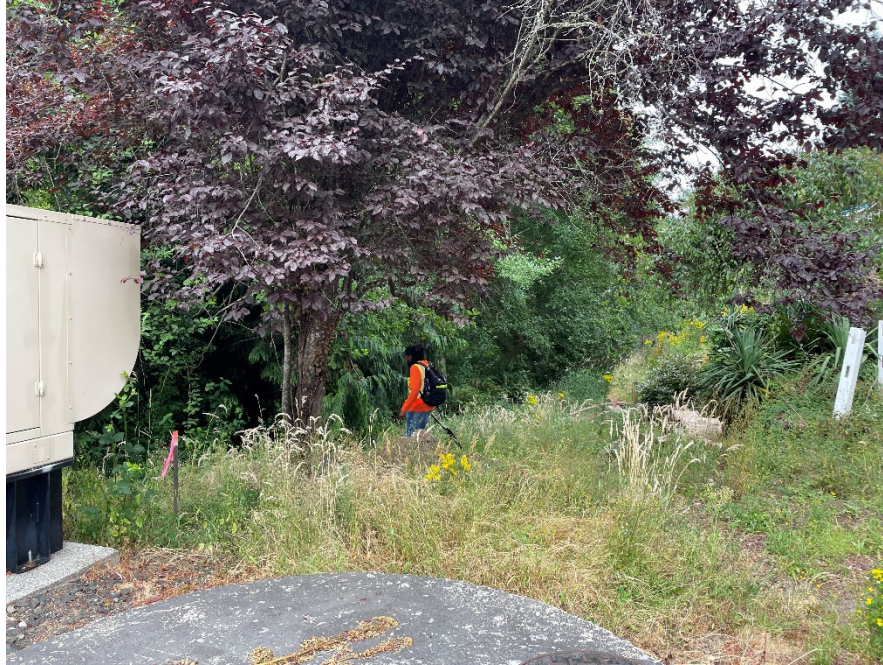
Photo 3

Looking southwest at the wetland buffer and wetland

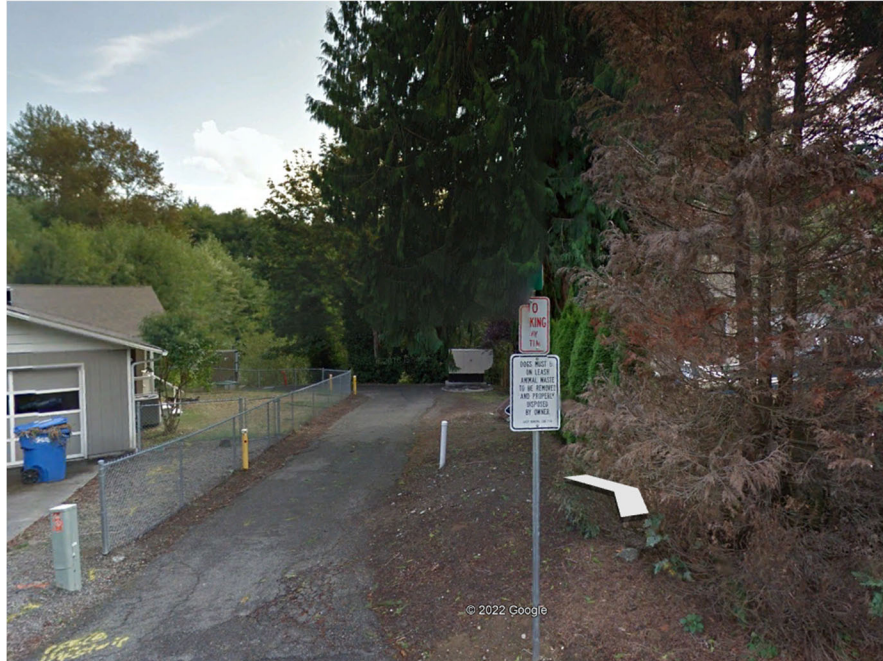
Photo 4

Looking south at the entrance to Lift Station 6

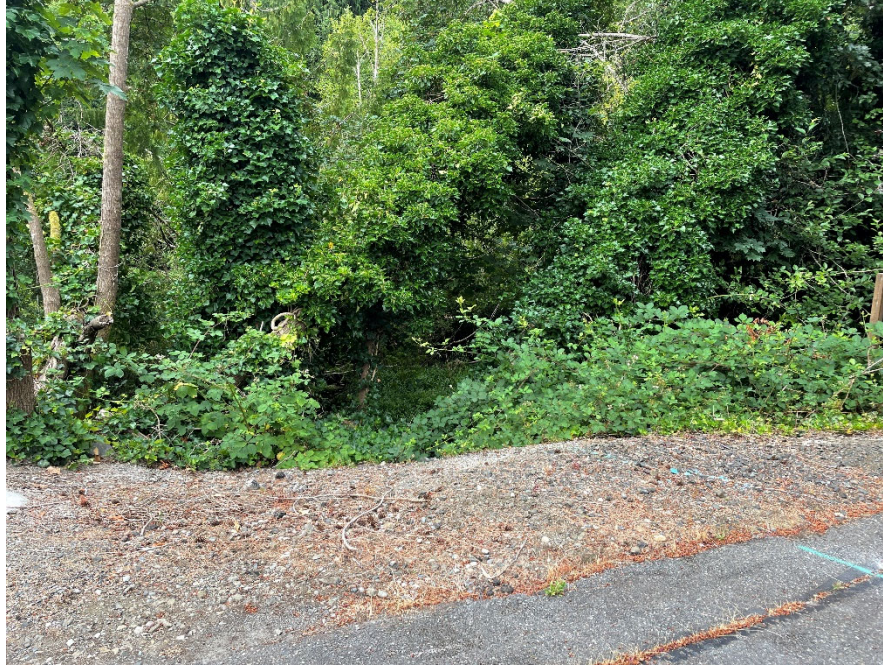
Photo 5

English ivy and Himalayan blackberry in the buffer
