# CITY OF LACEY, WASHINGTON

## LIFT STATION 6 REHABILITATION

60% SUBMITTAL

**SITE AND PIPING PLAN**  
PROJECT NO.: 22-3380.04 SCALE: AS SHOWN DATE: NOVEMBER 2022

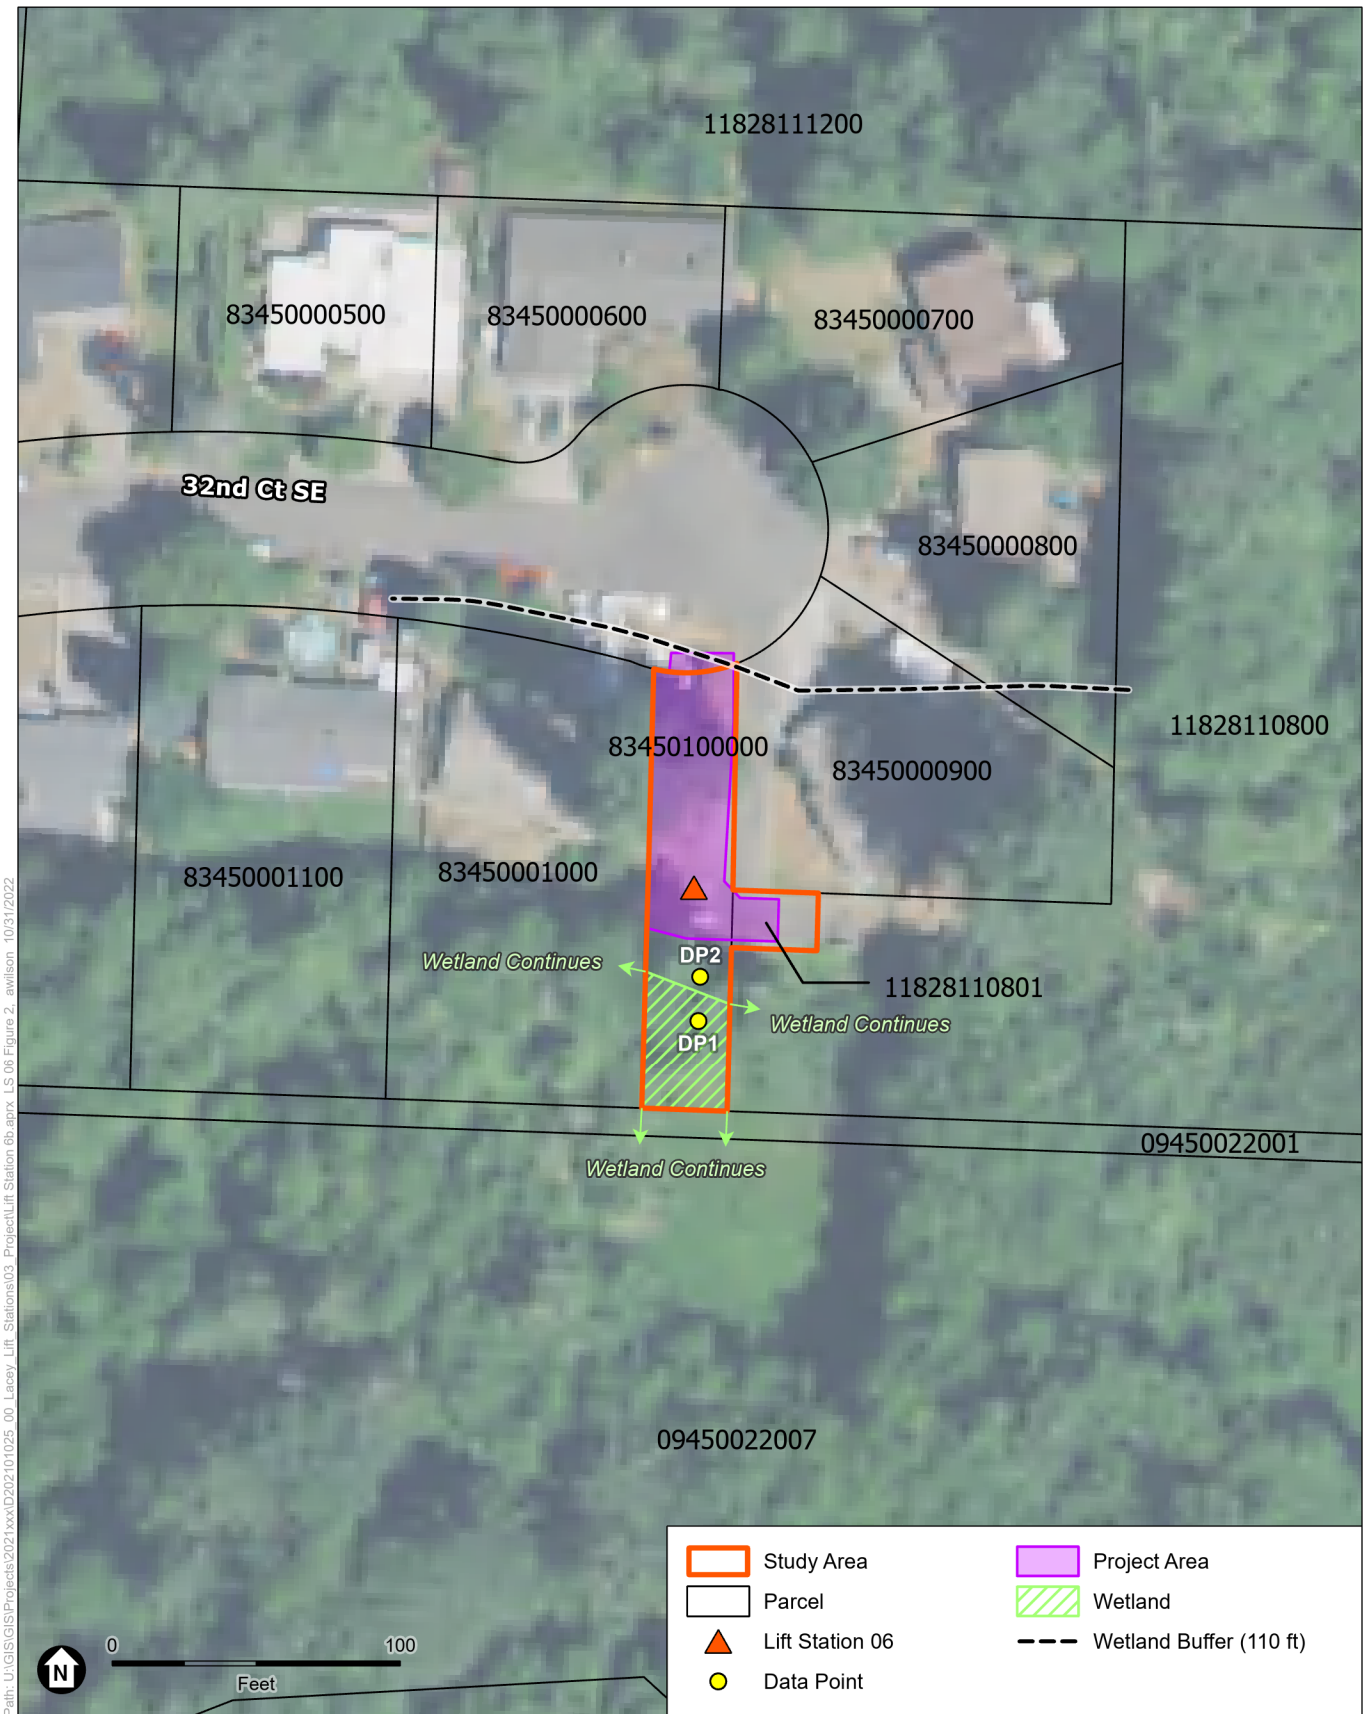
**Figure 4**  
Critical Areas - Wetland Delineation Map  
Lift Station 6

SOURCE: Imagery: USDA NAIP, 2021; Parcels: Thurston County, 2019; Recorded Wetlands: NWI, 2022; Survey Data: ESA, 2022

Site-specific delineation methods include traversing the study area to observe surface indicators of wetlands (reeds, rushes, willows, etc.; saturated soils or standing water) and establishing at least one set of paired data plots (DP#) to characterize wetland and non-wetland conditions. The methods also included establishing a minimum of one wetland plot in a low spot that overlaps with wetland mapping (DP1).

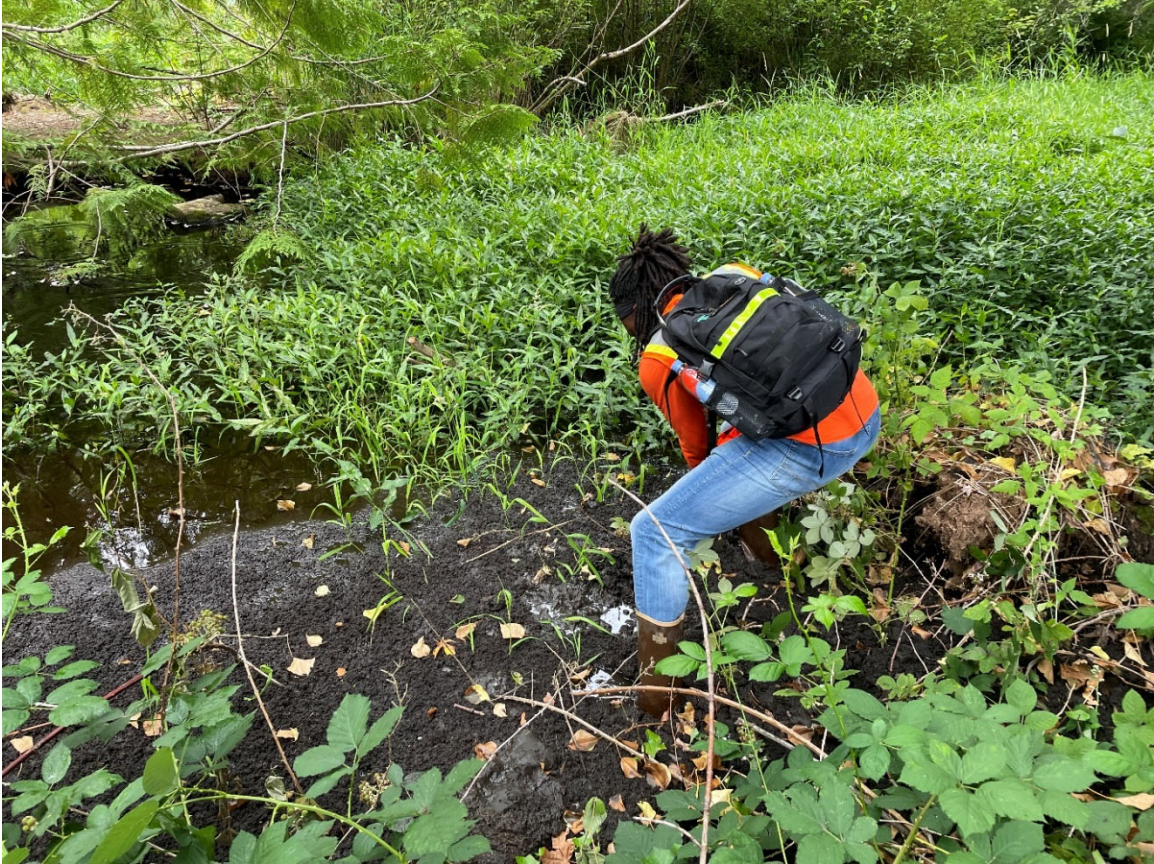
**Photo 1**

Wetland 1, DP1 facing southwest

During the time of field investigation, at least two inches of standing water (A1) was observed two feet away from DP1. At DP1, biologists observed a high water table (A2) and soil saturation (A3) measured to the surface of the soil plot.

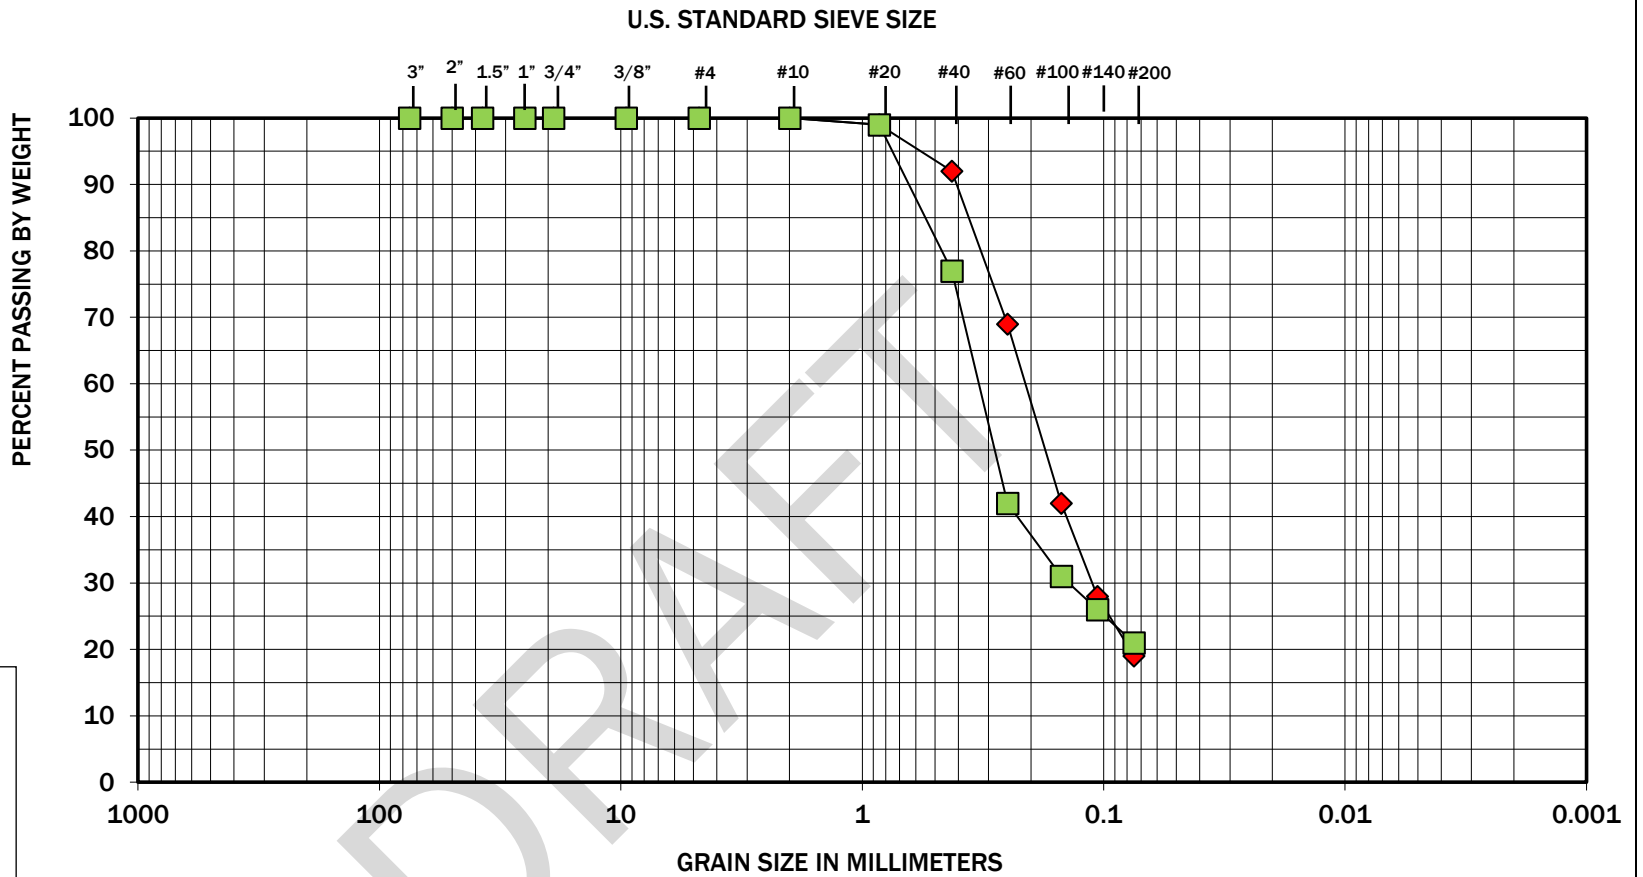
COBBLES	GRAVEL		SAND			SILT OR CLAY
	COARSE	FINE	COARSE	MEDIUM	FINE

Symbol	Boring Number	Depth (feet)	Moisture (%)	Soil Description
◆	B-2	15	26	Silty Sand (SM)
■	B-2	20	23	Silty Sand (SM)
