Geotechnical Engineering Report
Proposed Residential Development
5224, 5228, 5216 - 15th Avenue NE
Thurston County, Washington
PN: 11809310-600,-700, & -100
Doc ID: ThreesCompanyLLC.15thAveNE.RG

INTRODUCTION

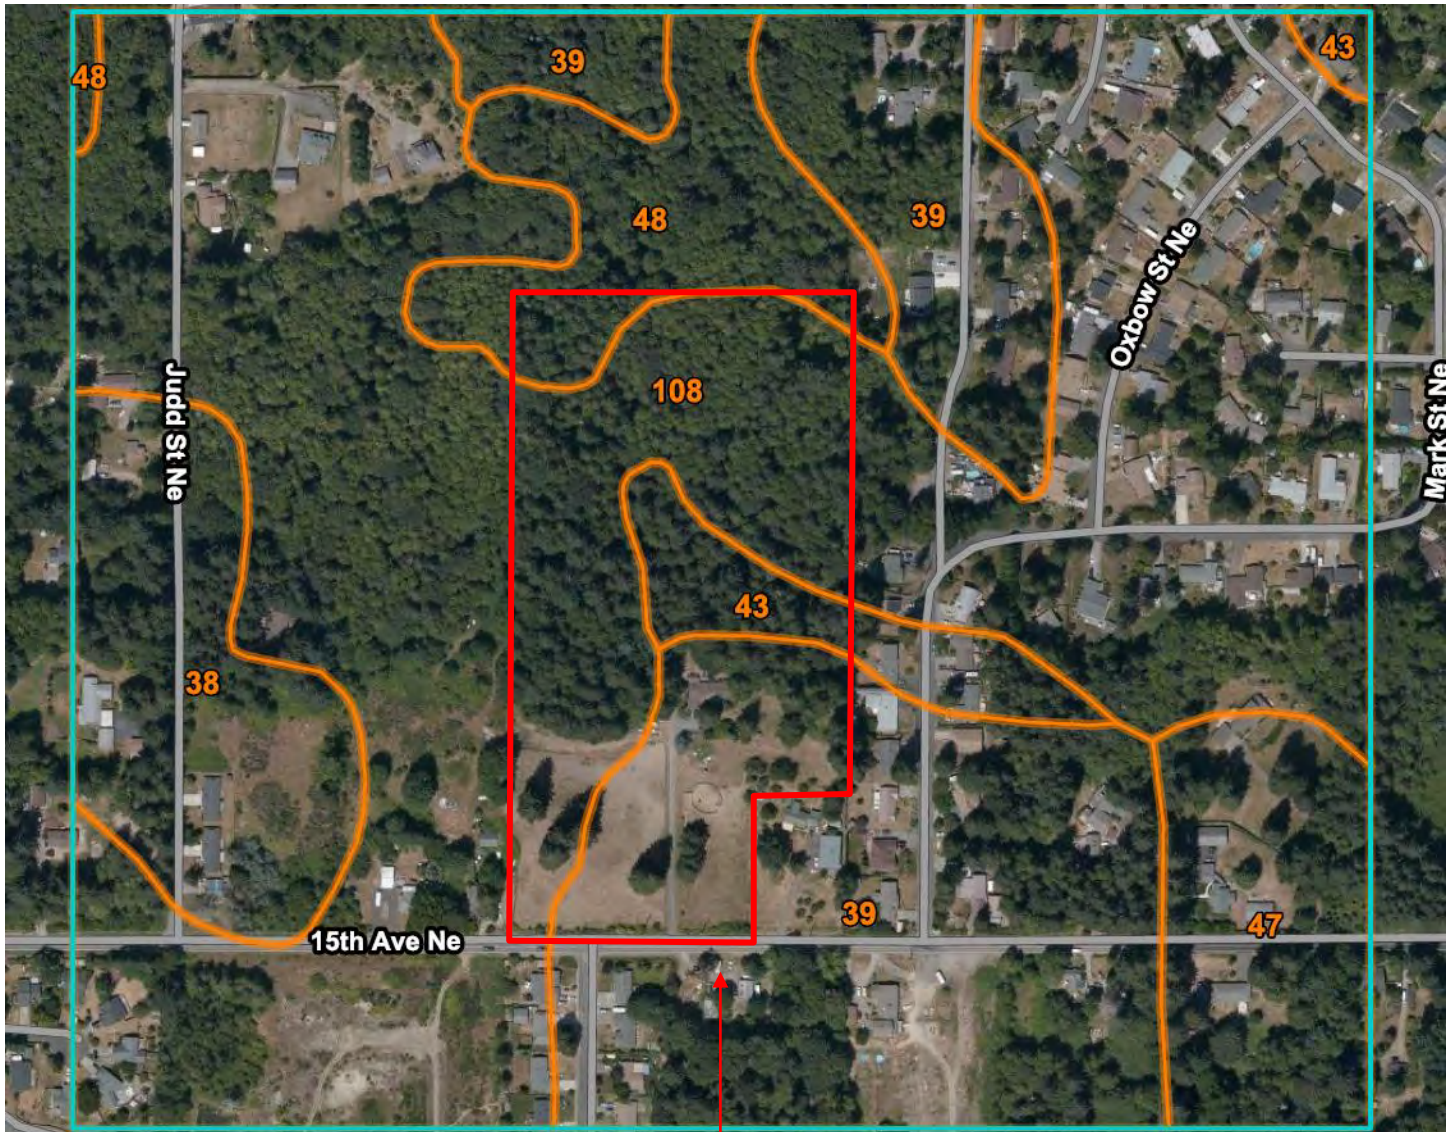
NRCS Soils Map

Map created from Web Soil Survey (<http://websoilsurvey.sc.egov.usda.gov/App/WebSoilSurvey.aspx>)

The USDA Natural Resource Conservation Service (NRCS) Web Soil Survey maps the site as being underlain by Giles silt loam (39), Hoogdal silt loam (43), Indianola loamy sand (48), and Skipopa silt loam (108) soils. The Giles soils, mapped as underlying the upper southeastern portion of the site, are derived from volcanic ash and glacial outwash and form on slopes of 3 to 15 percent. These soils have a "slight" erosion hazard when exposed and are included in hydrologic soils group B. The Hoogdal soils, mapped along the more steeply sloping, central portion of the site, are derived from loess and glaciolacustrine deposits, form on slopes of 15 to 30 percent, have a "moderate" erosion hazard when exposed, and are included in hydrologic soils group D. The Indianola soils, underlying the northeastern and northwestern corners of the site, are derived from sandy glacial outwash and form on slopes of 15 to 30 percent. These soils have a "moderate" erosion hazard when exposed and are included in hydrologic soils group A. The Skipopa soils, mapped in the upper southwestern and lower northern portions of the site, are derived from volcanic ash over glaciomarine deposits, form on slopes of 3 to 15 percent, have a "slight" erosion hazard when exposed, and are included in hydrologic soils group D. A copy of the soils map for the site vicinity is provided as Figure 3.

As previously stated, the site is underlain by Giles silt loam (39) and Skipopa silt loam (108) which both have a “slight” erosion hazard when exposed and Hoogdal silt loam (43) and Indianola loamy sand (48) which have a “moderate” erosion hazard when exposed. No evidence of active or ongoing erosion was observed at the time of our site visits. In our opinion, the site does not have an active erosion hazard.
