# Williams Crossing

Preliminary Stormwater Site Plan Report

March 6, 2024

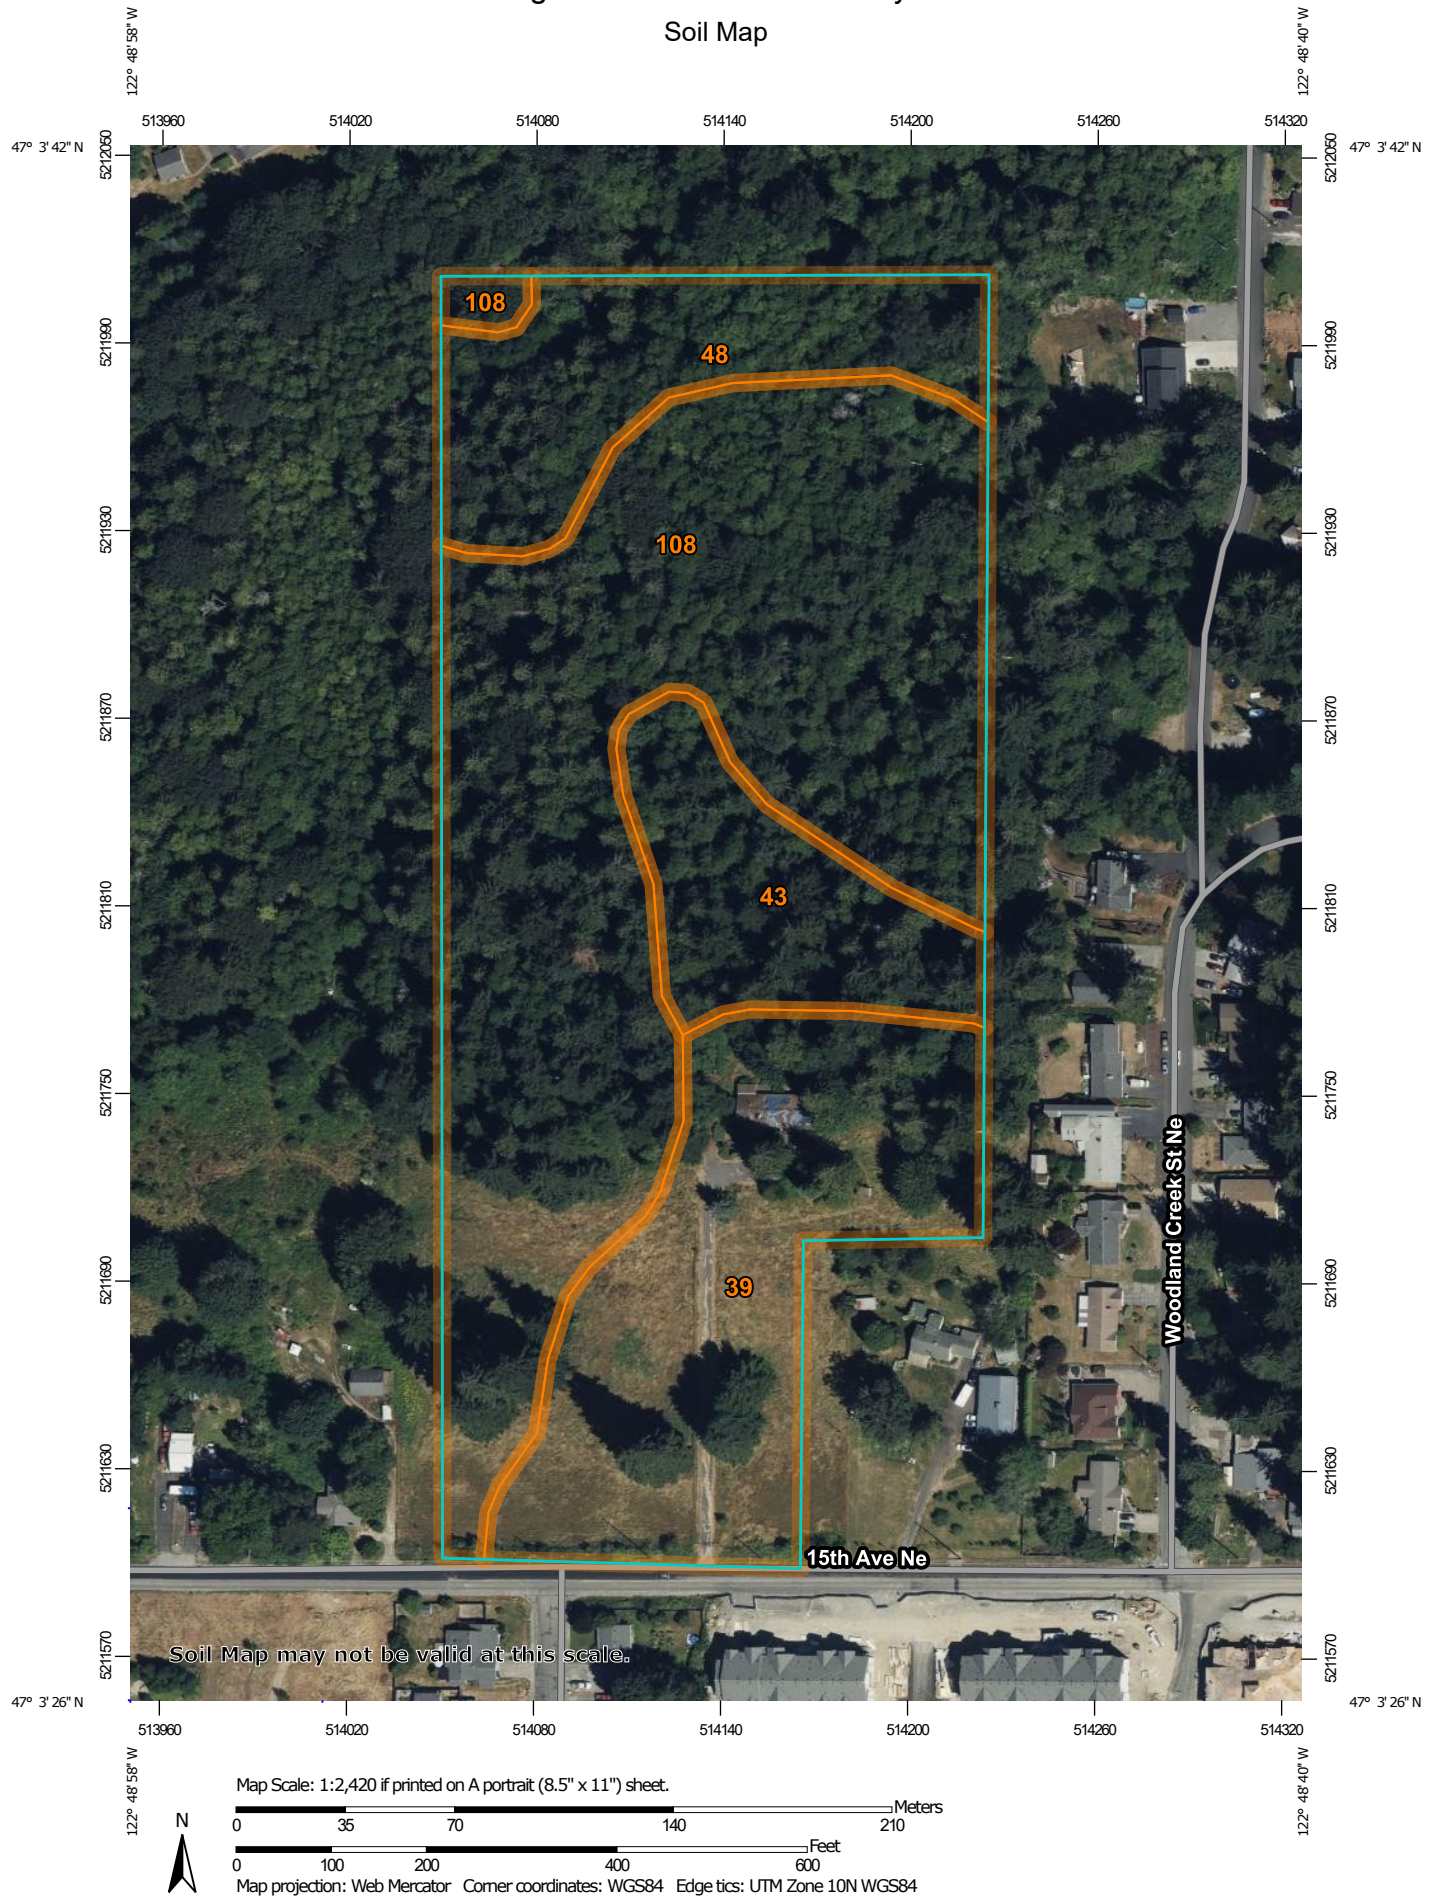
Figure 1.4 - Web Soil Survey  
Soil Map

The existing 18.7 acres site is predominantly trees, shrubs, and grass vegetation. The onsite soil types are mapped as Giles Silt Loam (Type B soils), Hoogdal Silt Loam (Type D soils), Indianola Loamy Sand (Type A soils), and Skipopa Silt Loam (Type D soils). Type A and B soils are conducive to infiltration. Since Indianola Loamy Sand (Type A soils) are located at the downstream end of the site, runoff from the site is anticipated to infiltrate. Stormwater runoff will continue to infiltrate in developed condition.

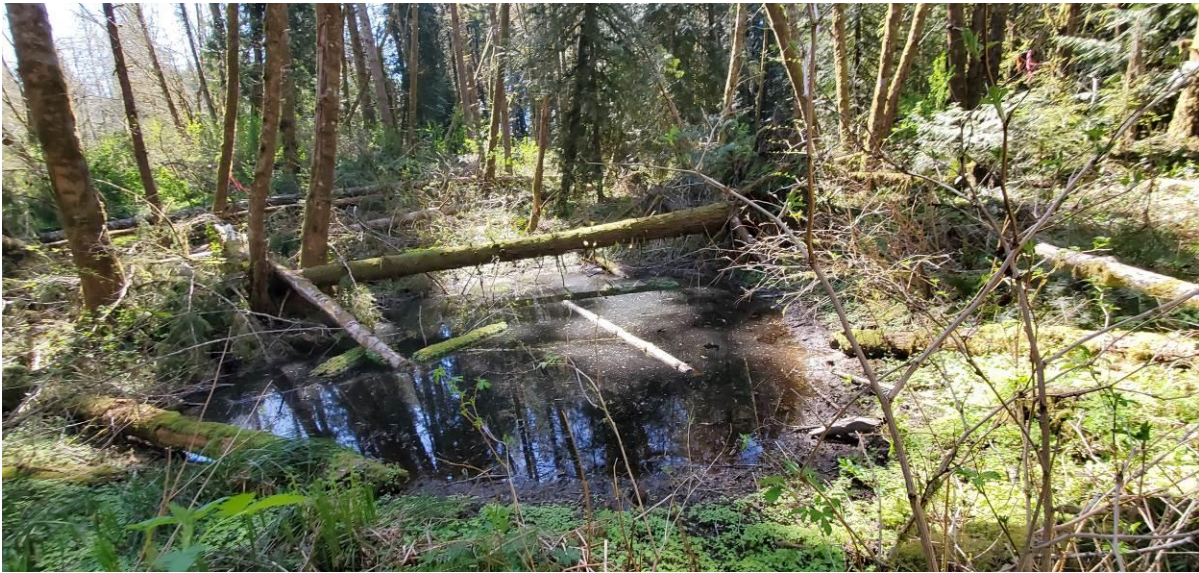
Photograph 5. View looking at small pond (likely excavated historically) within Wetland B. Pond is approximately 400 square feet in size.
