- Tree Protection Plan -

JUBILEE LODGE ADDITION

8487 Bainbridge Loop NE
Lacey WA 98516

Prepared for: Jubilee Community Association
Prepared by: Washington Forestry Consultants, Inc.
Date: April 17, 2024

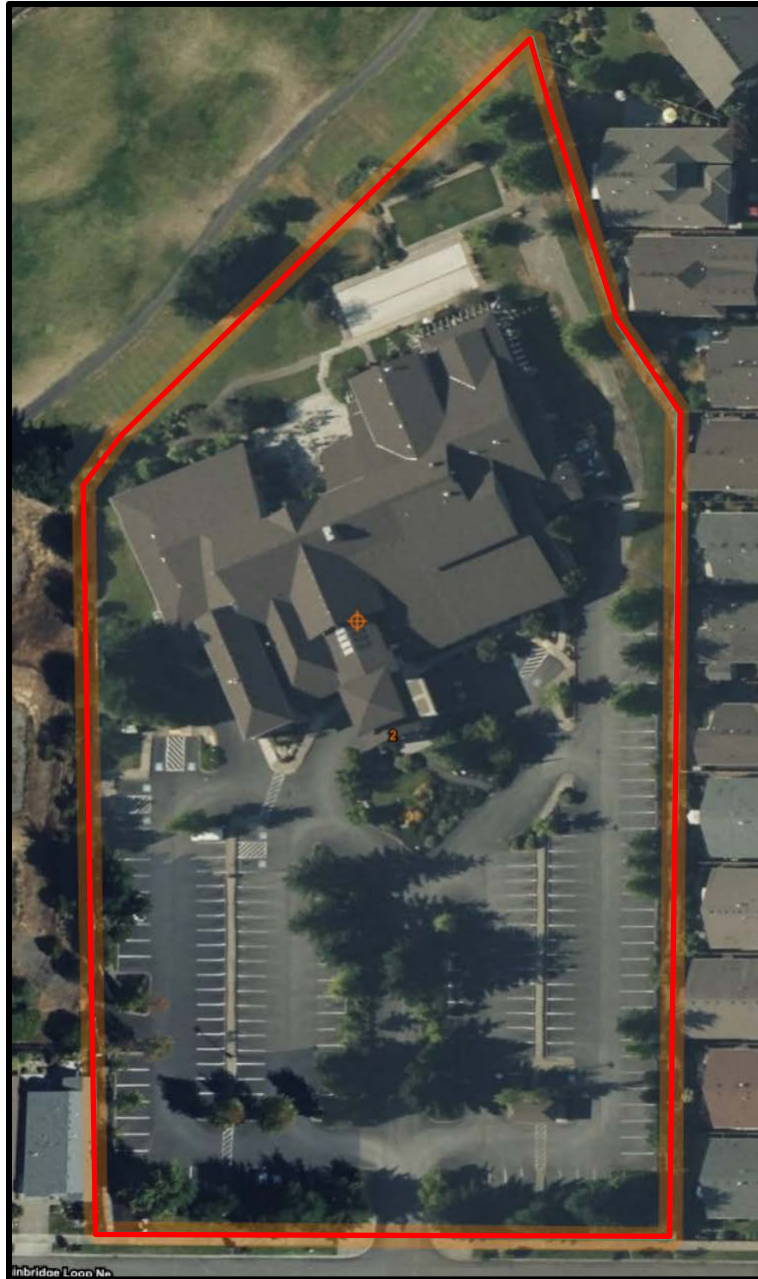
Figure 1. Soil Map of Jubilee Lodge Addition site.

2- Alderwood gravelly sandy loam

According to the Thurston County Soil Survey the one soil type on the site is the Alderwood gravelly sandy loam, a moderately deep, moderately well drained soil found on glacial till plains. It is formed in ablation till overlying basal till. A weakly cemented hardpan is at a depth of 20 to 40 inches. Permeability is moderately rapid above the hardpan and very slow in the pan. Available water capacity is low. Effective rooting depth is 20-40 inches. A perched seasonal high-water table is at a depth of 18-36 inches from November to March. The potential for windthrow of trees is moderate under normal conditions. New trees require irrigation for establishment.

In areas where grading brings the hardpan nearer to the surface, the hardpan must be fractured under new trees to provide soil volume for root development and to improve drainage around the tree.

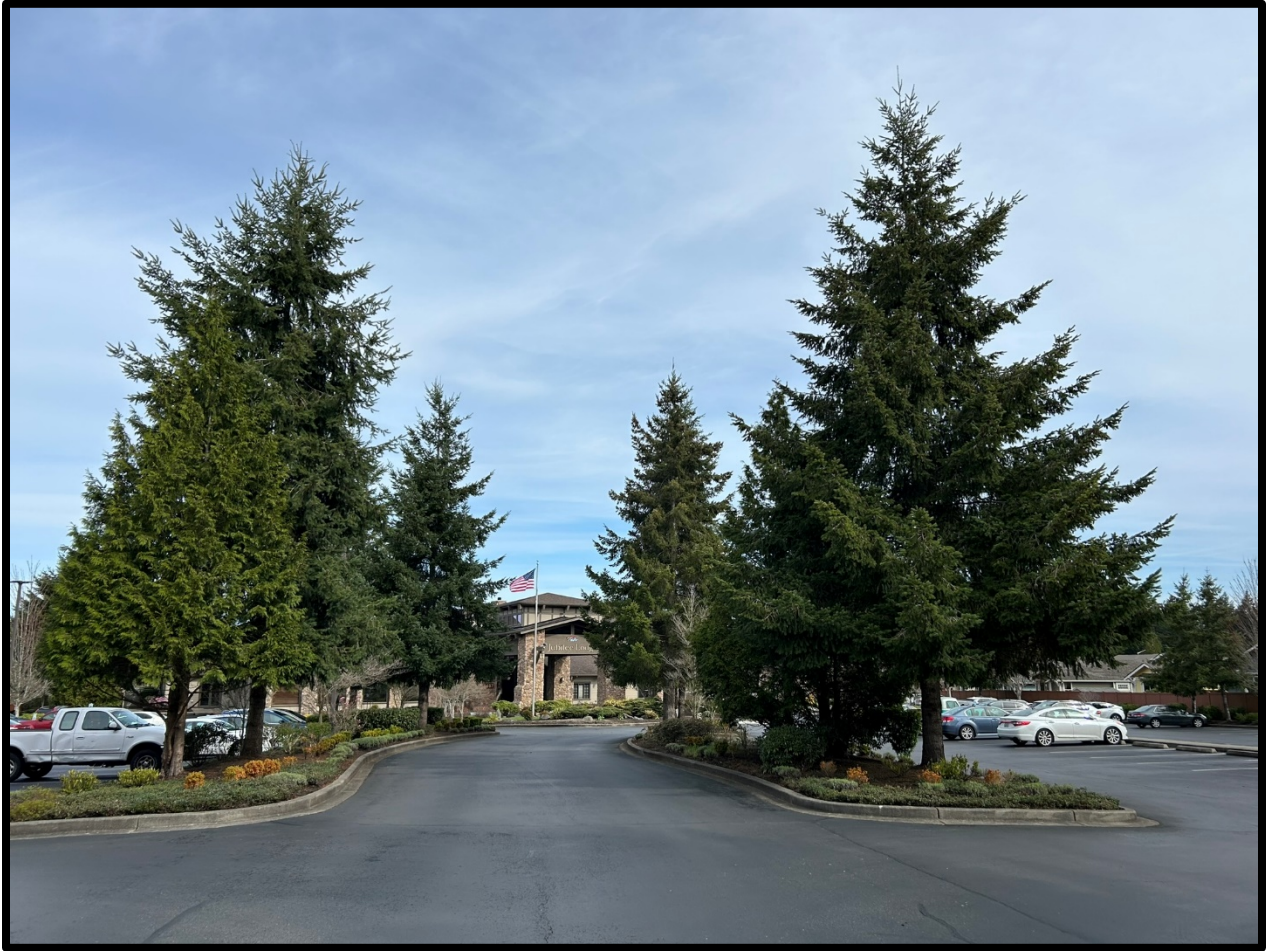
Photo 1. View of trees on The Lodge Addition site.

Type I.- The trees on the site are all landscape plants that were planted during site development. Species include Alaska cedar (*Callitropsis nootkatensis*), crab apple (*Malus sylvestris*), an unknown deciduous, deodar cedar (*Cedrus deodara*), Douglas-fir (*Pseudotsuga menziesii*), flowering dogwood (*Cornus florida*), hawthorn (*Crataegus spp.*), star magnolia (*Magnolia stellata*), red maple (*Acer rubrum*), and western redcedar (*Thuja plicata*). Tree size ranges from 4 to 18 inches DBH. There are a total of 86 trees ≥ 4 inches DBH planted throughout the landscaping and another 64 trees that are smaller than 4 inches DBH. The condition of trees ranges from ‘Very Poor’ to ‘Very Good’, with all but one tree classified as healthy. The root zones of most trees are limited by the planting beds. Some trees are beginning to cause lifting of the parking lot asphalt.

The understory shrub stocking includes various shrubs, small, non-significant sized trees, grasses, and broadleaved weeds.

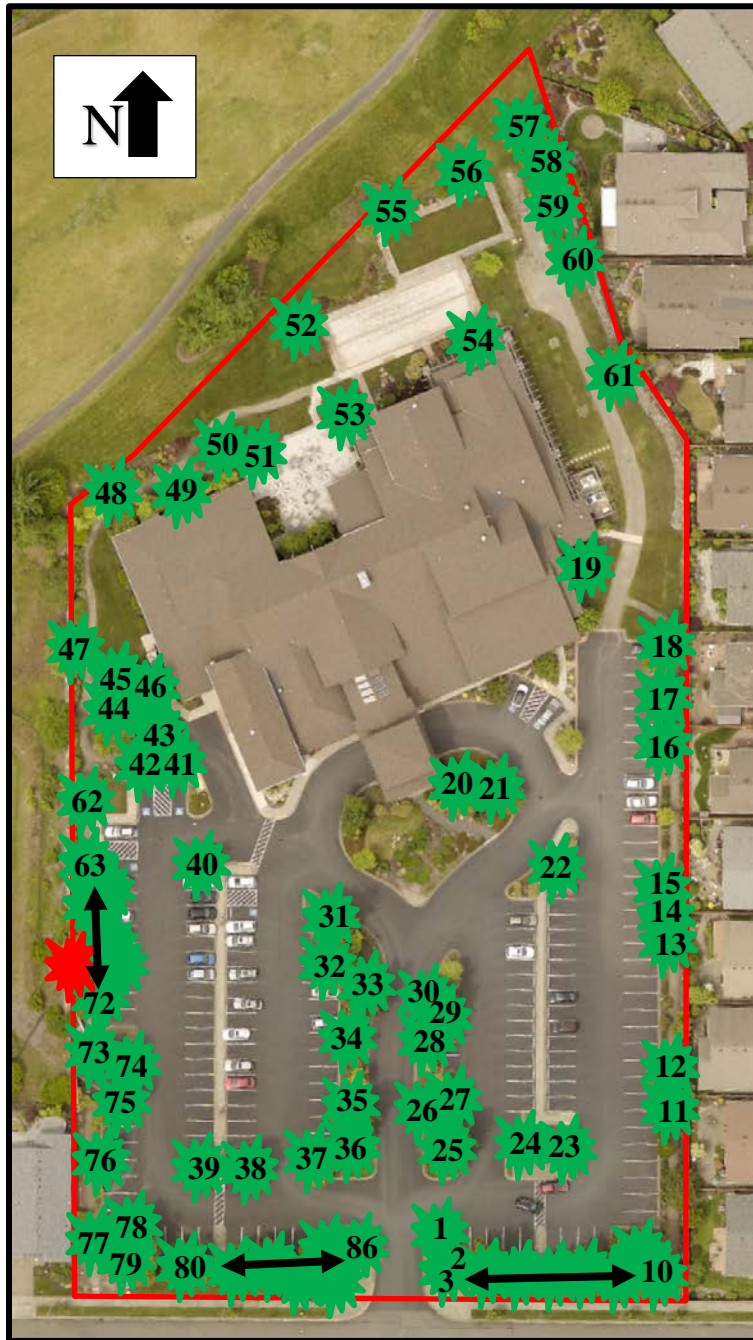
Attachment 1. Aerial Photo of Jubilee Lodge Addition Parcel

— Project Area Boundary

★ Healthy Tree

★ Unhealthy Tree

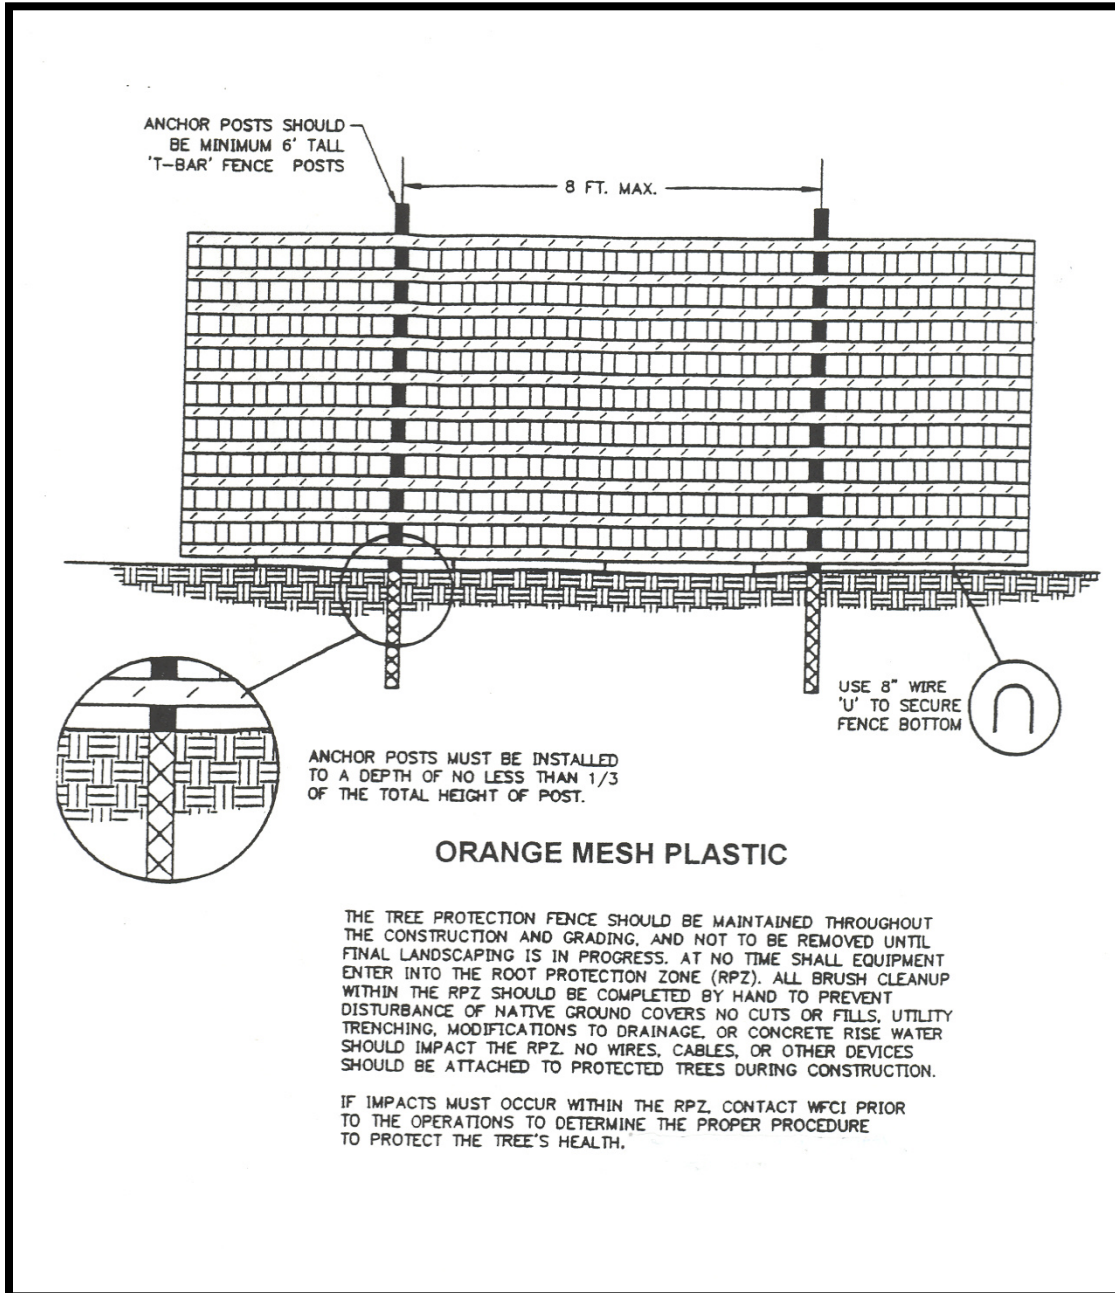
Attachment 4. Tree Protection Fence Detail

Trees and tree tracts to be saved must be protected during construction by temporary orange mesh fencing on driven posts, located at the edge of the critical root zone. The individual critical root zones are 5 feet outside the dripline of all edge trees unless otherwise delineated by WFCI.

There should be no equipment activity (including rototilling) within the critical root zone. No irrigation lines, trenches, or other utilities should be installed within the critical root zone. If roots are encountered outside the critical root zone, they should be cut cleanly with a saw and

covered immediately with moist soil. Noxious vegetation within the critical root zone should be removed by hand. If a proposed save tree must be impacted by grading or fills, then the tree should be re-evaluated by WFCI to determine if the tree can be saved and mitigating measures, or if the tree should be removed.
