- Preliminary Tree Protection Plan -

**BRITTON NORTH**

2365 Shady Lane Ct. NE  
Lacey, WA 98516

Prepared for: Lacey Community Development  
Prepared by: Washington Forestry Consultants, Inc.  
Date: December 7, 2021

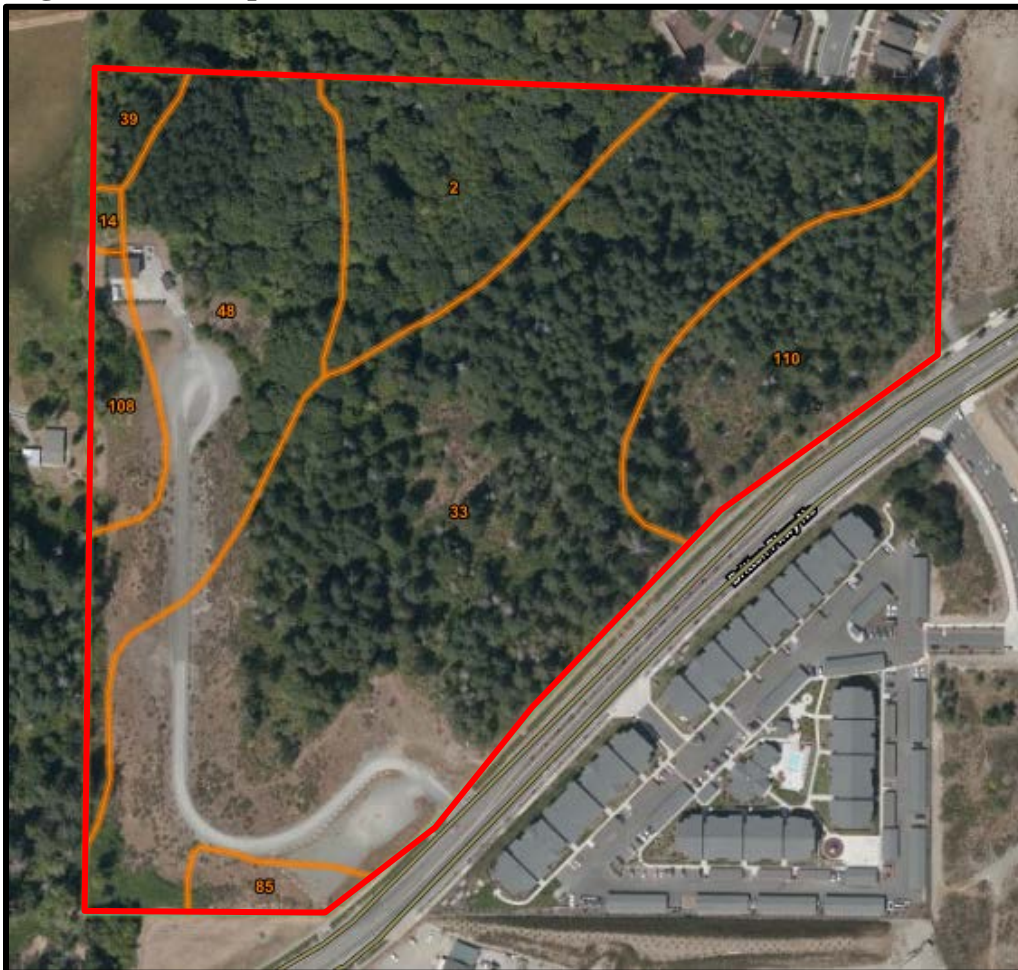
**Figure 1. Soil Map of Britton North Site.**

According to the Natural Resource Soil Conservation Survey there are 8 soil types on the site. The gravel pit type is part of the Everett very gravelly sandy loam type.
